## Barrandov Bridge is back in full operation

Prague, 17 October 2022 - On Monday morning, drivers were able to drive on the newly reconstructed section of the Barrandov Bridge, the busiest traffic artery in Prague, for the first time. PORR workers started the first stage of the reconstruction on 16 May this year and during the course of the project they completely replaced the Strakonice ramp, including repairing and reinforcing the southern part of the Barrandov Bridge. Fears of serious traffic complications or even traffic collapse did not materialize. This is mainly due to the maximum commitment and good cooperation of all involved, and not least thanks to the understanding, patience and consideration of all drivers.

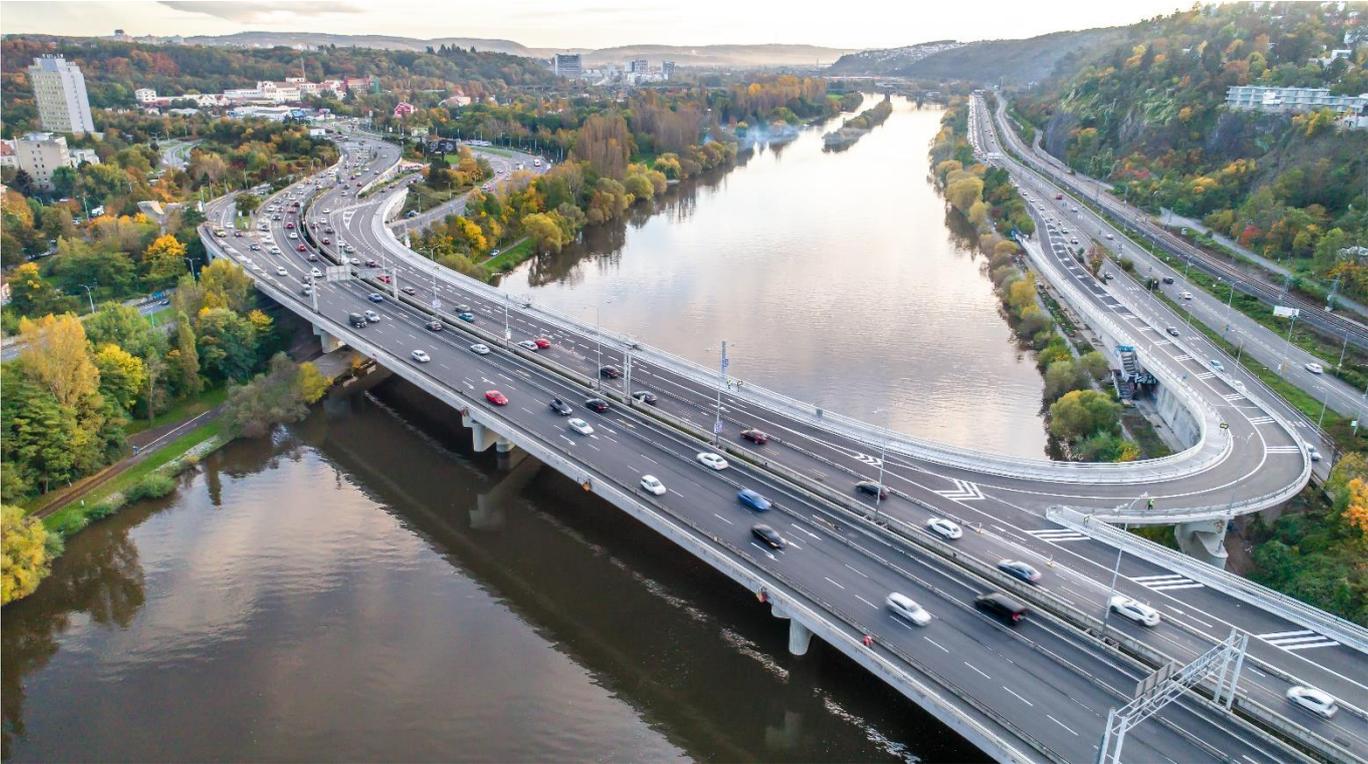
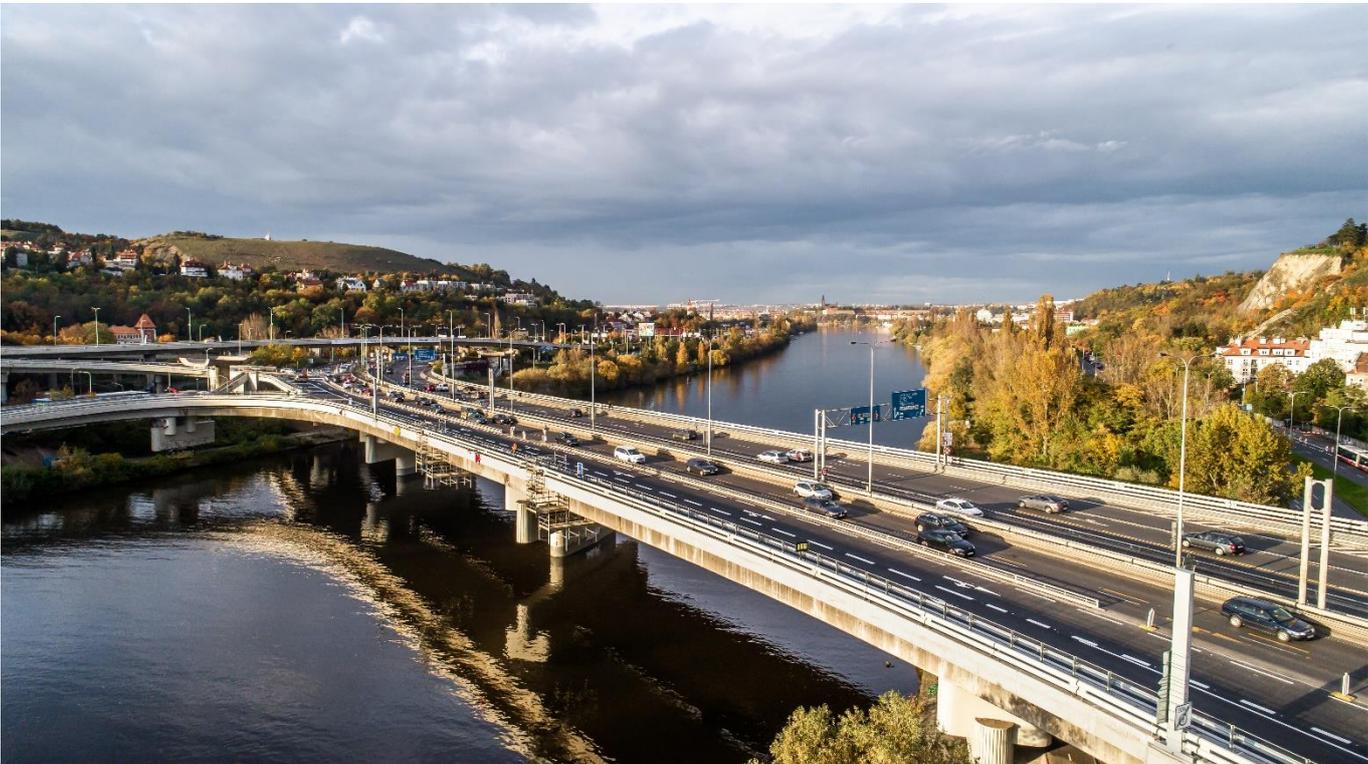
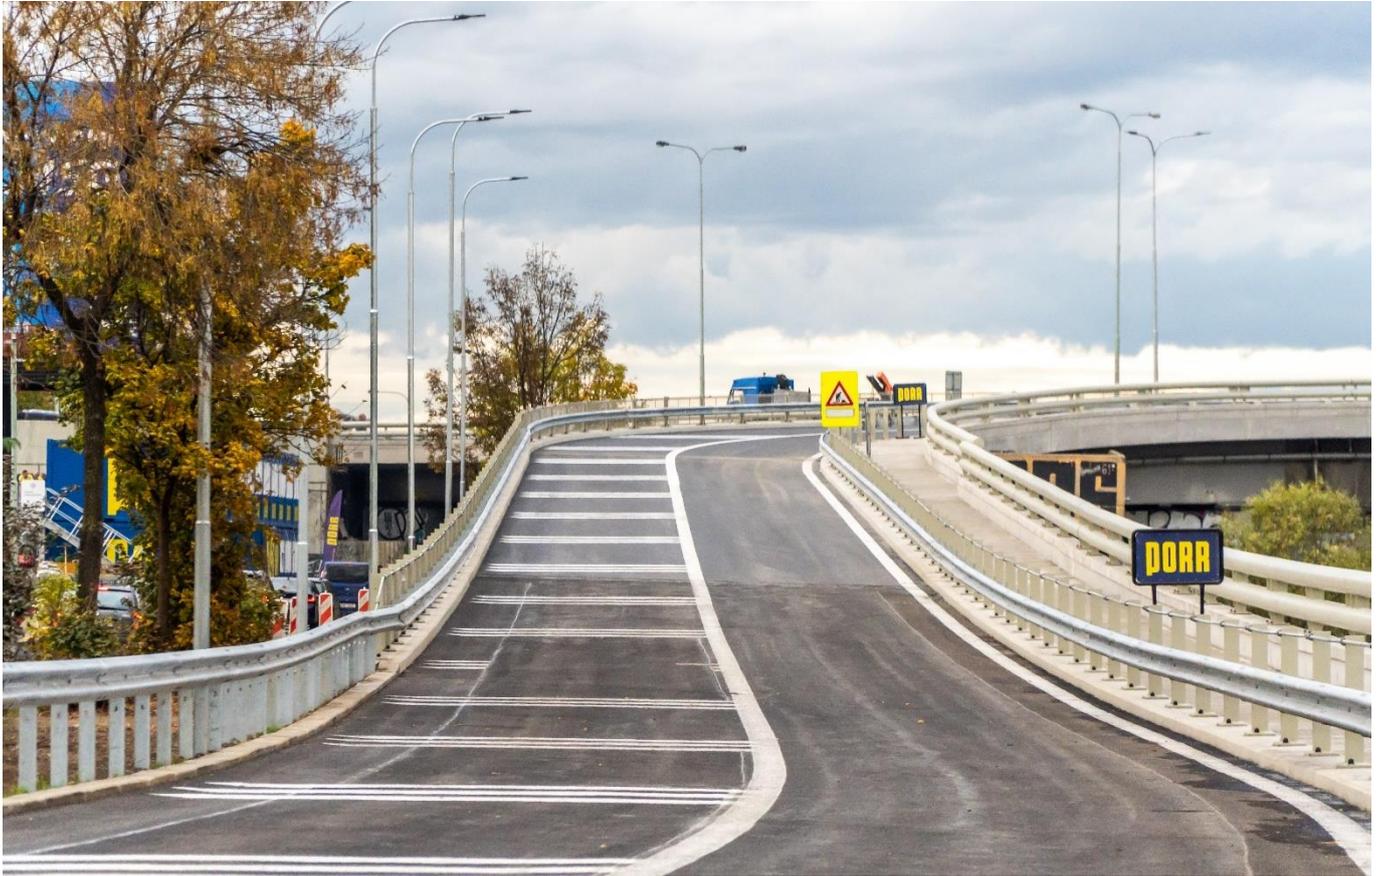
*During the 1st stage of reconstruction we repaired the southern part of Barrandov Bridge and completely replaced the Strakonicka ramp. © PORR*
